Site 24 Salisbury Beach Reservation – Black Rock Beach

Great Marsh Coastal Wetlands Restoration Plan
Rapid Technical Assessment Site 24

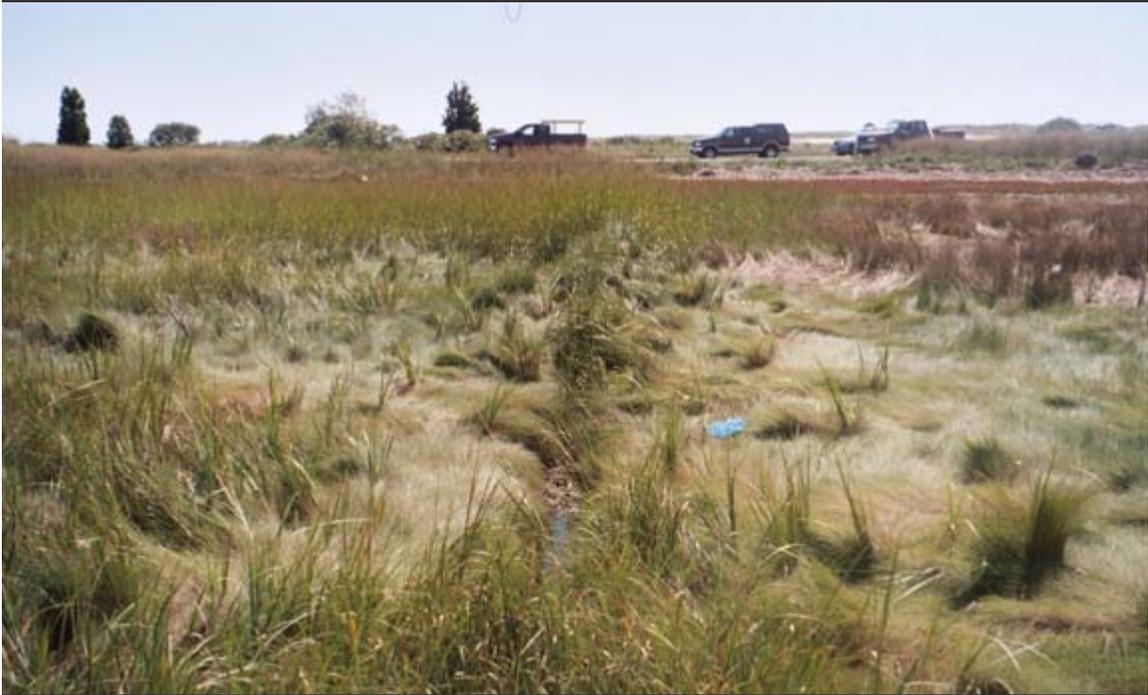
Photo 1 - Salt Marsh North of Boat Ramp Access Road Viewing South

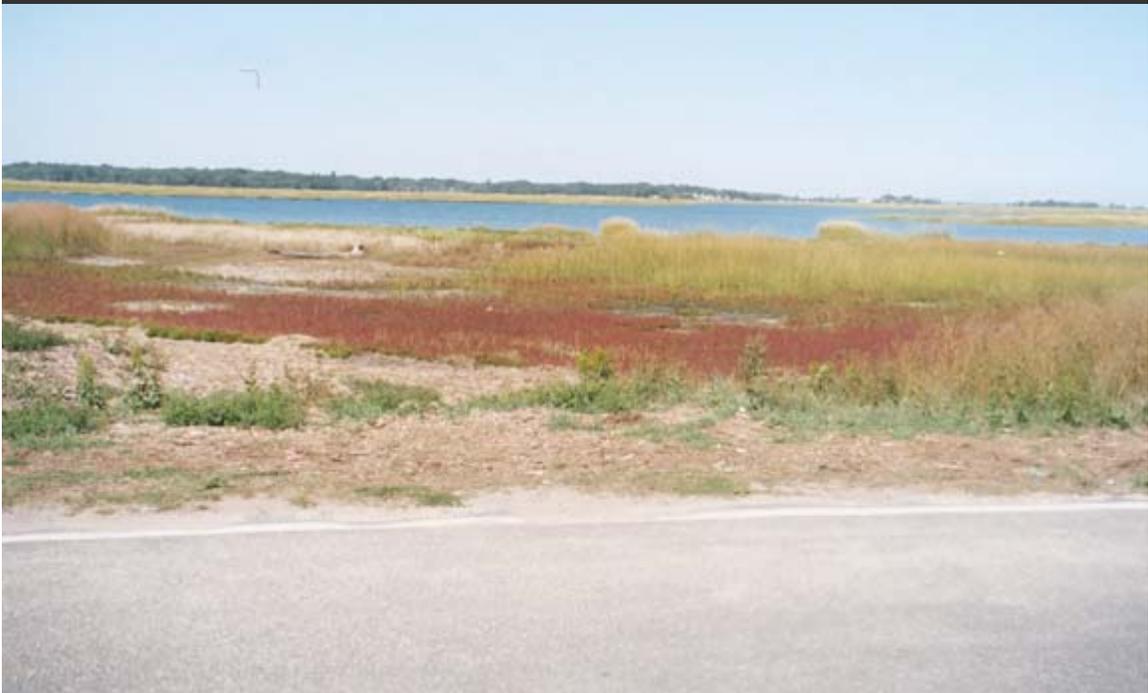
Photo 2 - Salt Marsh North of Boat Ramp Access Road Viewing North

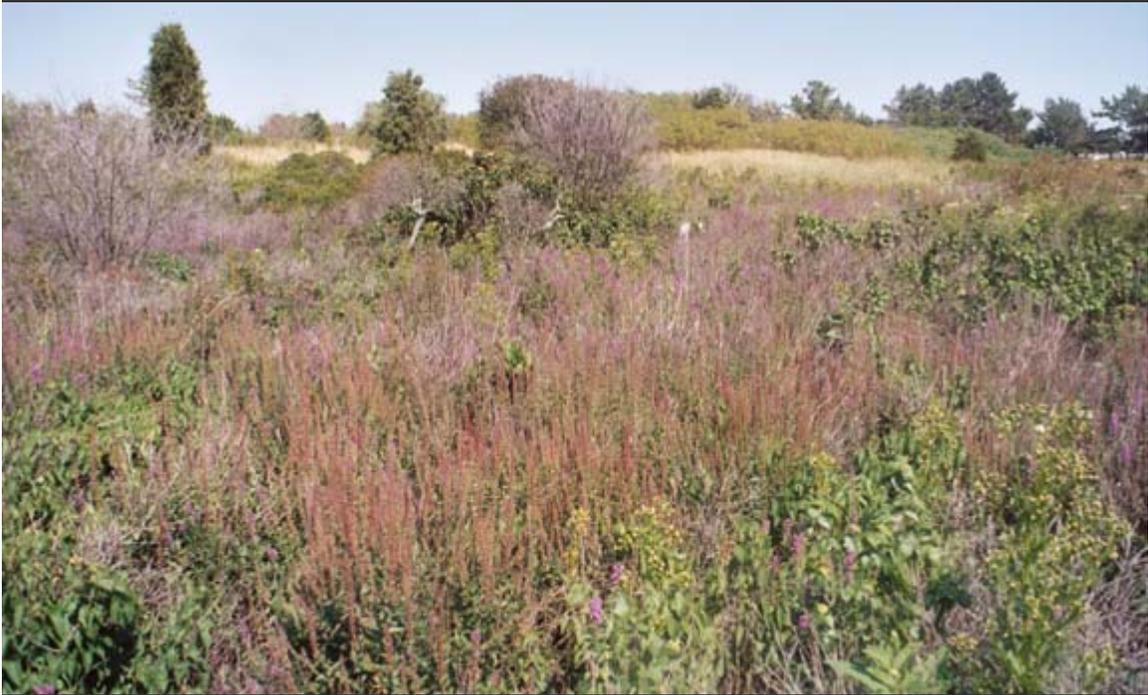
Photo 3 - Purple Loosestrife within Restoration Area

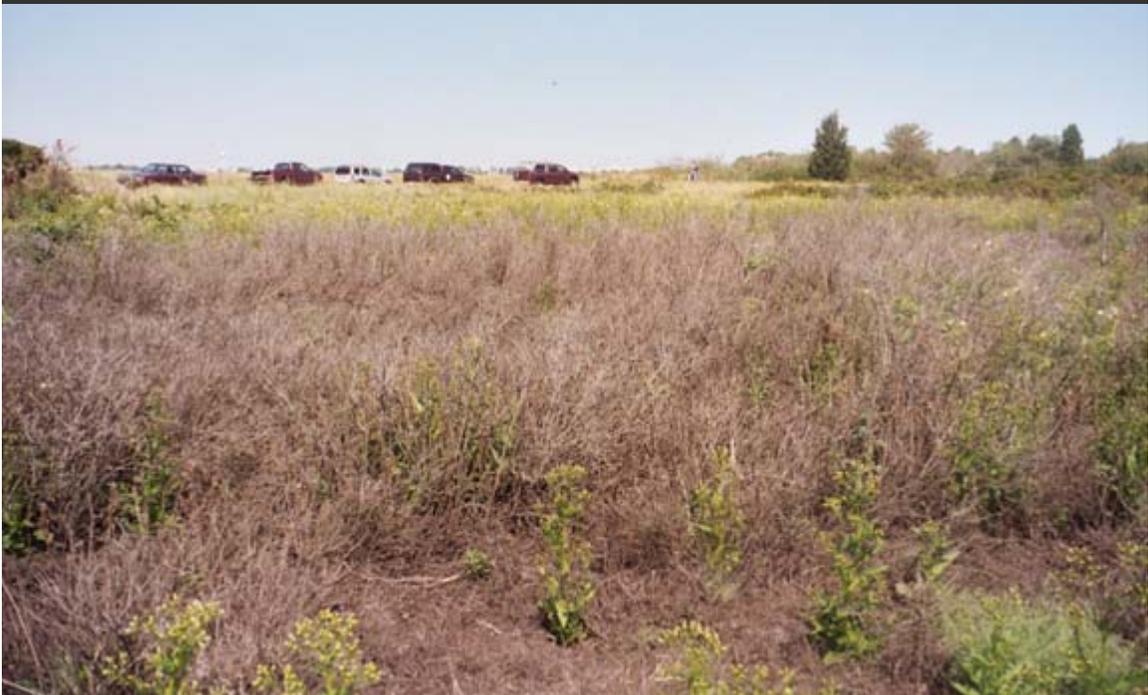
Photo 4 - Restoration Area Viewing Northeast

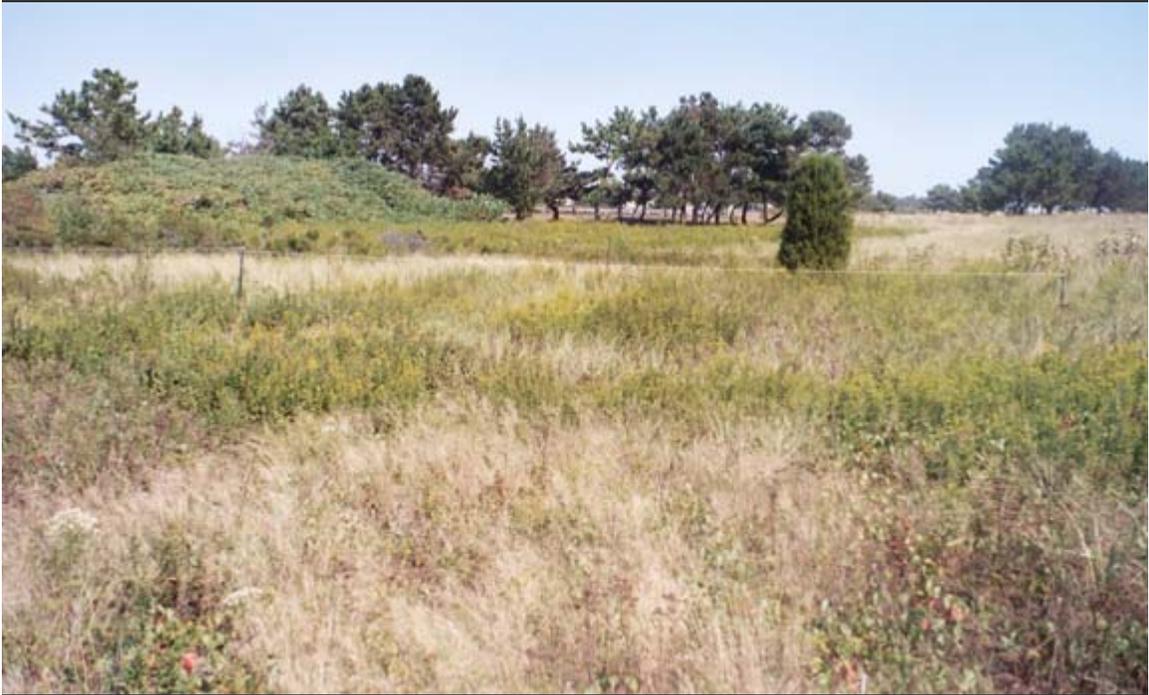
Photo 5 - East End of Restoration Area Viewing East

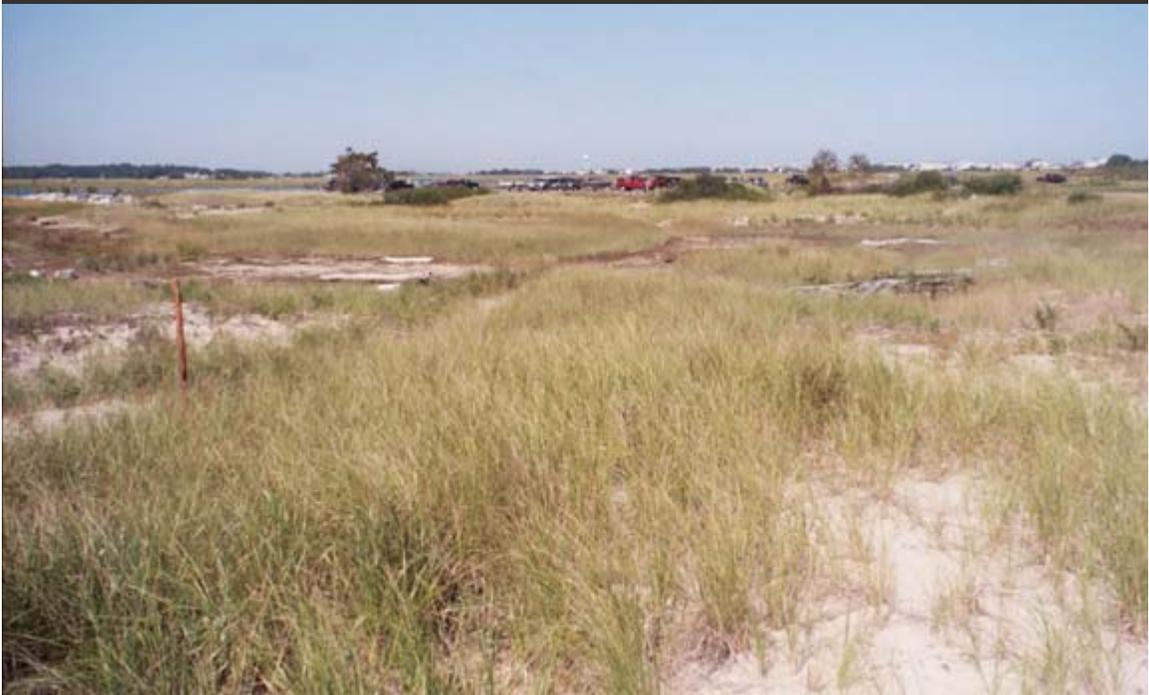
Photo 6 - Dune Area West of Parking Lot Viewing North

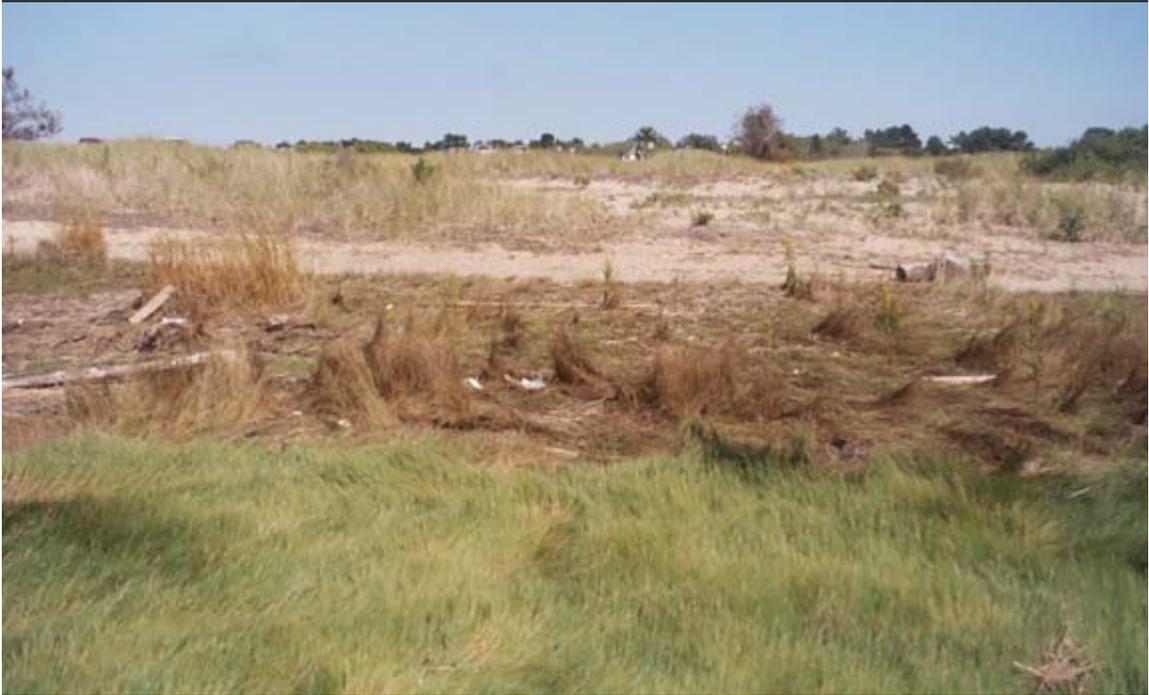
Photo 7 - Dune Area West of Parking Lot Viewing East
